Infrared Study of a Piston Ring Temperatures in a Fired Engine

Final Technical Report

Dr H A Spikes

November 1990

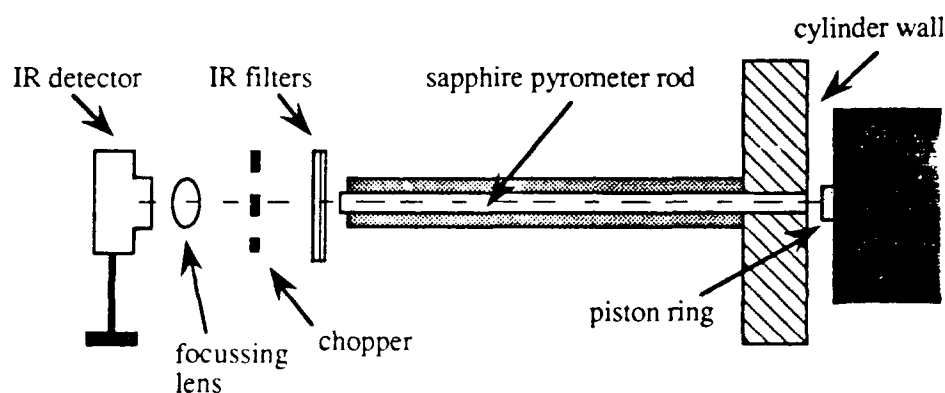
Proposed dual wavelength system

A schematic diagram of the proposed dual wavelength system is shown below. A sapphire pyrometer rod will be embedded in the cylinder wall to replace the sapphire window currently in use, this will give a more efficient transfer of radiant energy from the contact zone to the IR detector. It will also remove any spurious IR contributions from the laboratory environment. Radiance measurements will be made at two discrete wavelengths determined by two narrow band IR filters that are mounted on a moveable slide within the optical path. This will allow measurements to be made concurrently at each wavelength and the ratioed result and hence temperature determined.

Two components of the originally proposed work have not yet been accomplished. One is the development of a dual wavelength technique. The aim of this was to measure IR radiance at two different wavelengths which would overcome the need to measure in a separate calibration emissivity of the surfaces involved. A system has been designed for this and is shown in appendix 1. However delays in delivery and other equipment problems meant that it was not possible to test this within the time available.

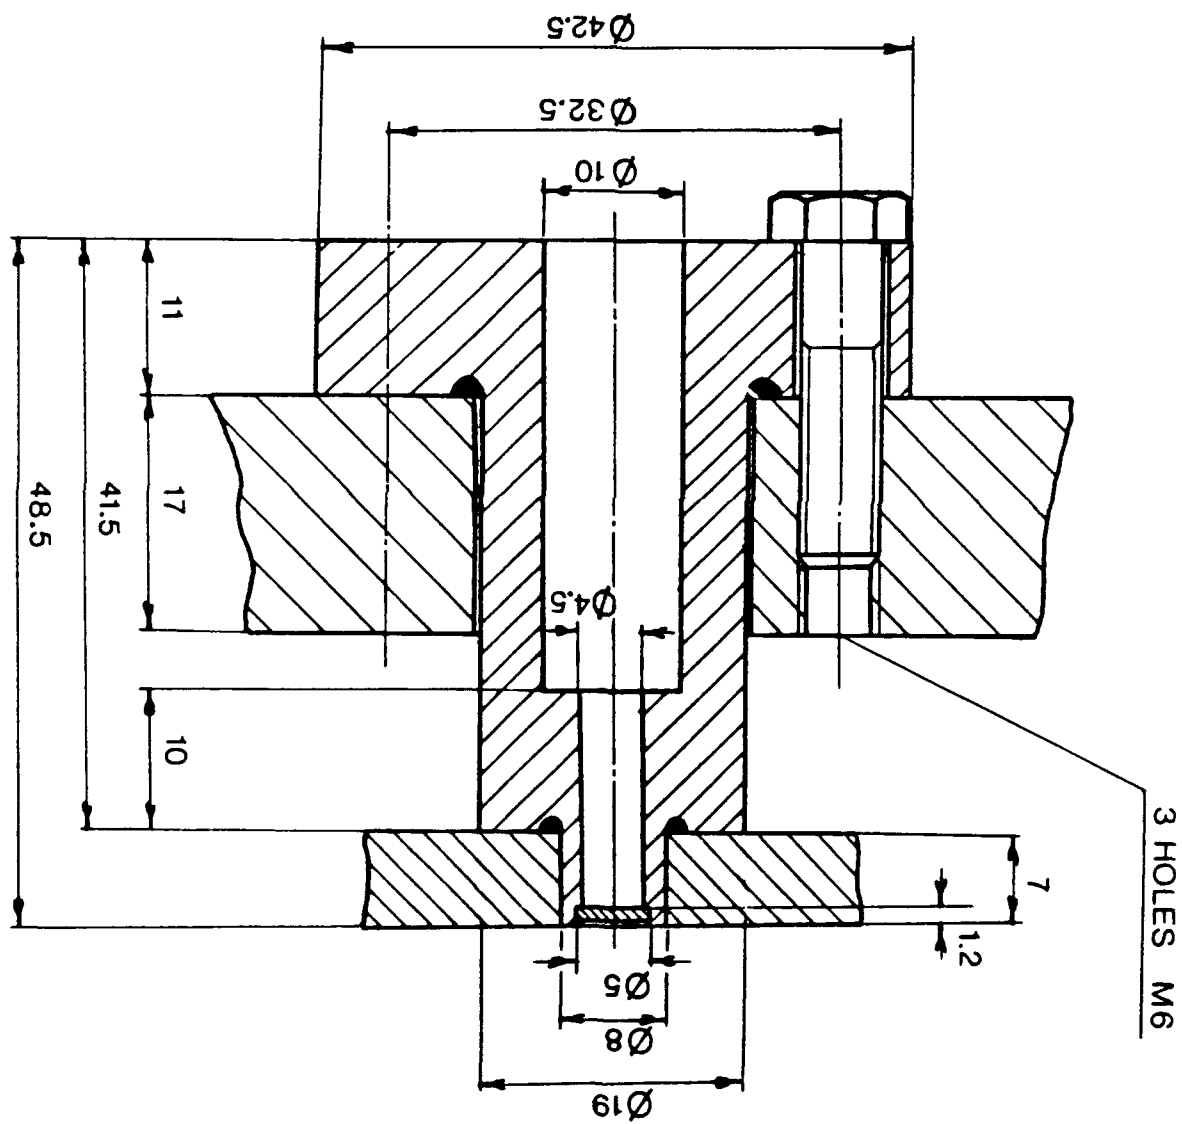
Figure 1. Window Design

Each window holder was sealed against the outer liner wall with a copper seal and compression of this seal using a screw thread enabled accurate control of the spacing between cylinder liner surface and window surface. In the first half of this study the windows used were set back from the cylinder liner by 0.10 to 0.25mm. At a later stage the sapphire was fitted slightly proud of the liner and then diamond-honed to form a curved surface flush with the liner wall. A diagram of the window holder design is shown in figure 1.

A single cylinder Petter AV1 diesel engine was employed in this study. Three window holders were made from chilled cast iron and inserted in the cylinder wall at positions corresponding to the centre of the top compression ring at top dead centre, mid stroke and bottom dead centre respectively. The ring pack of the engine employed has three compression and two scraper rings.

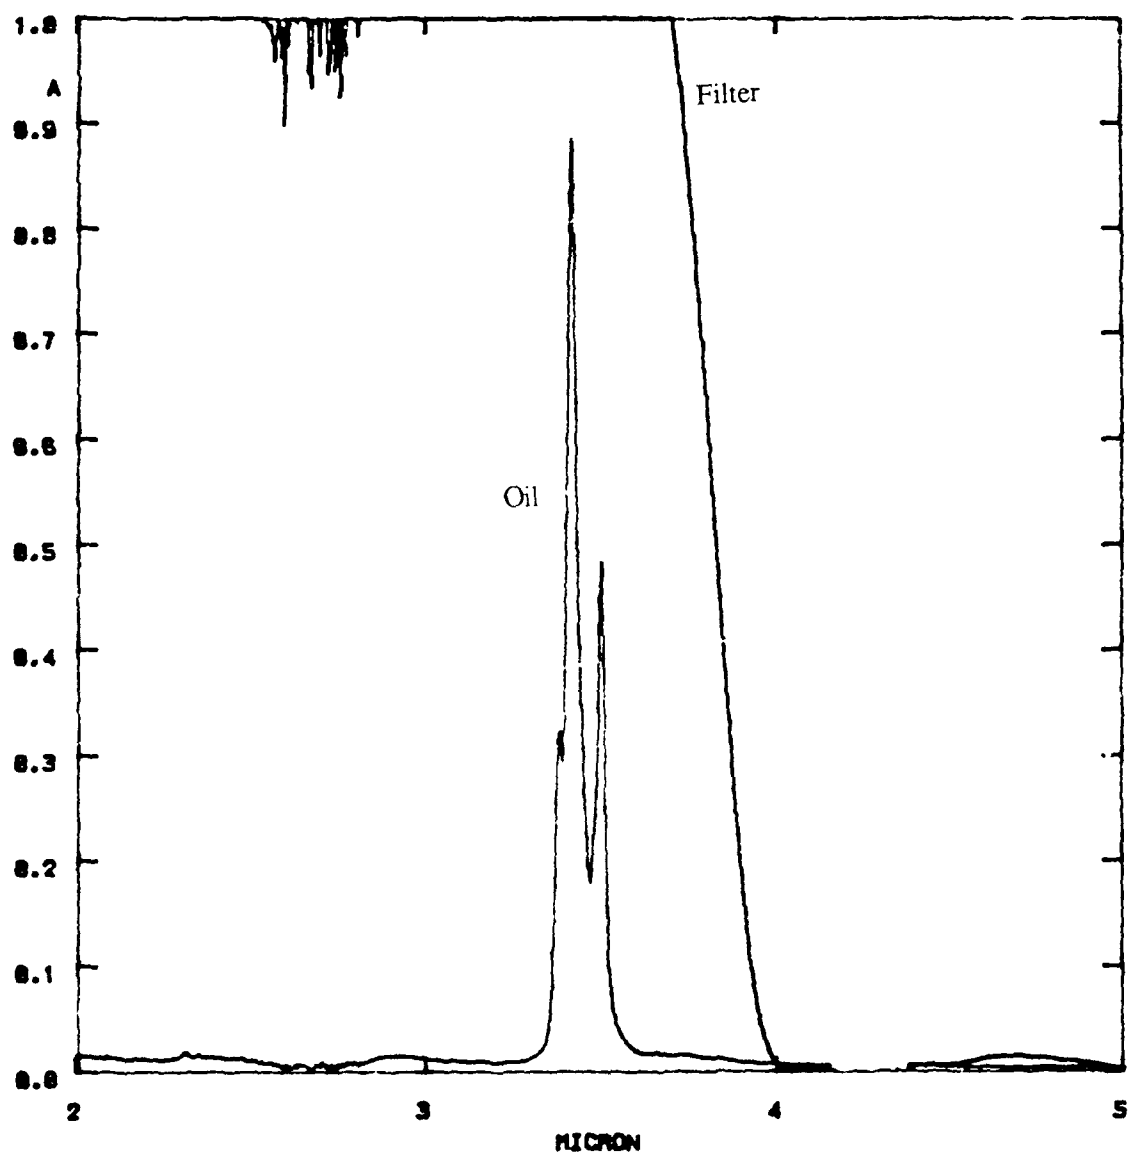
Figure 3. IR Absorbance Characteristics of Filter

With the window set back from the liner surface there is a likelihood of oil being trapped between ring and window. There may also be a significant quantity of oil between piston lands and liner. This could have two effects on the measured infrared emission. Firstly there might be emission, not just from the piston ring metal surface but also from this trapped oil. Secondly there is a possibility that the oil film will absorb radiation emitted from the ring surface. In an attempt to limit the effect of emission from the oil, an infrared filter was introduced between engine and IR microscope. This filter was chosen to selectively remove the infrared radiation in the frequency range emitted by hydrocarbon-based oils whilst still transmitting most of the lower frequency radiation emitted by hot metal surfaces. The filter absorption characteristics are shown in figure 3.

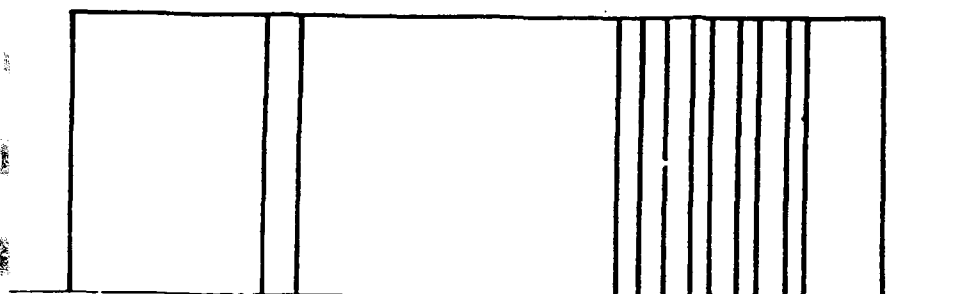
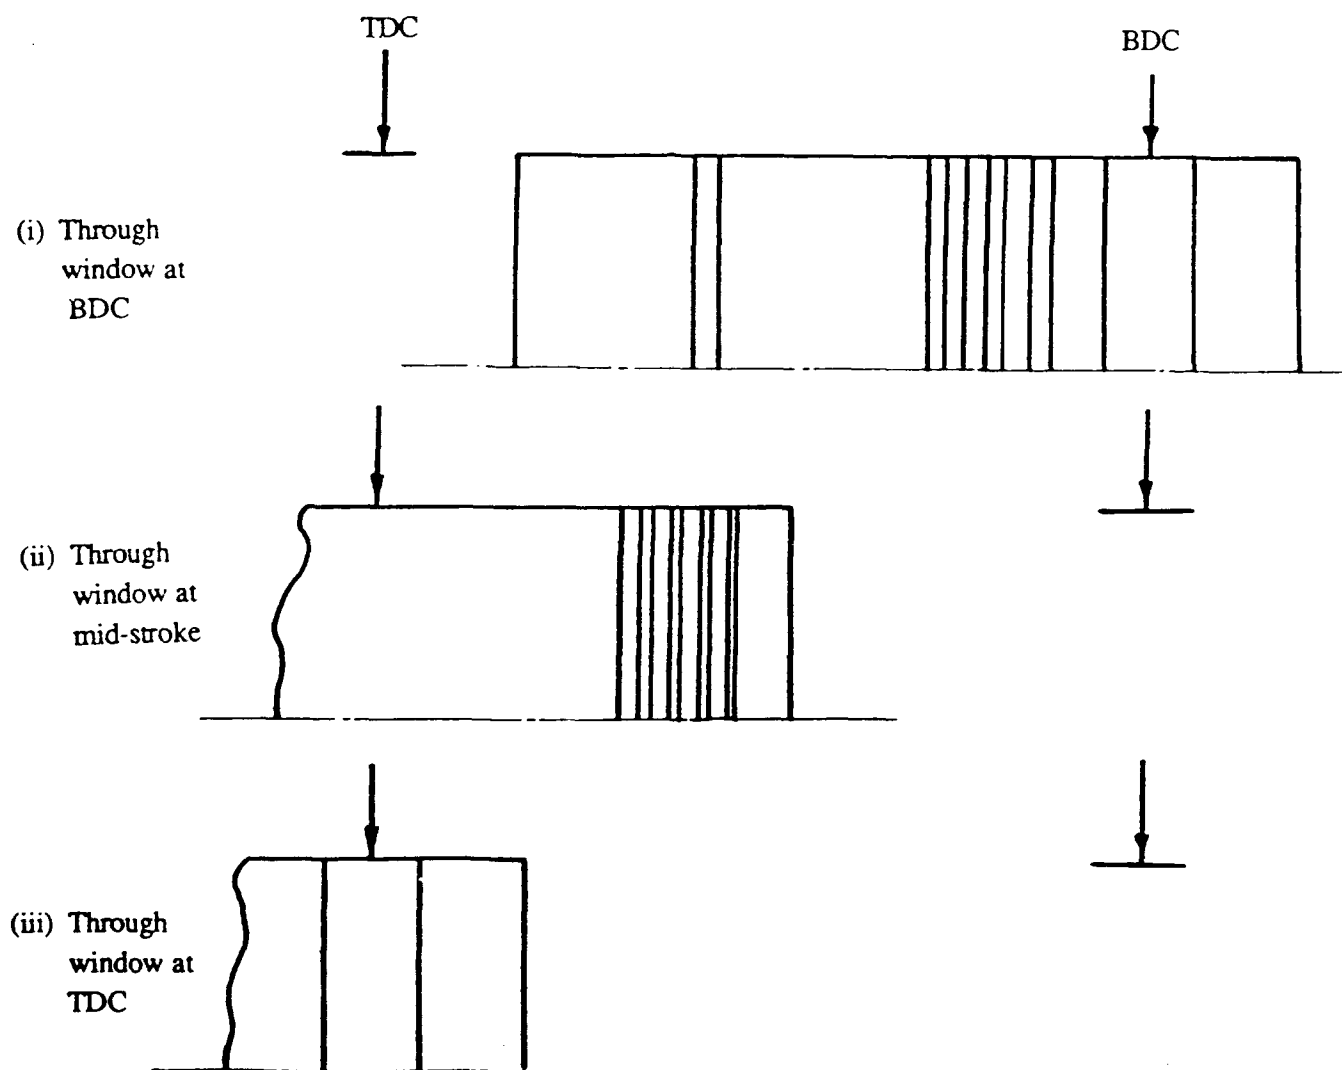
Figure 4. Influence of Motion on Apparent Piston Shape

To facilitate interpretation of results, sketches of the view of the piston as it passes each window have been prepared and are shown in figure 4. These, in effect, transform the piston from being linear with respect to actual size to being linear with respect to time of passage past the window and can thus be superimposed on the linear time scale oscilloscope voltage trace. As can be seen from the figure, for a window at mid-stroke, the areas of the piston that pass the window at around the middle of the stroke are effectively squashed, whereas parts that pass the window whilst the piston is reversing are elongated. By contrast, for a window at top dead centre the upper half of the top piston appears stretched.

In interpreting the results it is important to be aware of just what portion of the piston surface is being observed by the microscope at any given time. This is not straightforward since the piston is reciprocating and is thus moving at varying speed past the window.

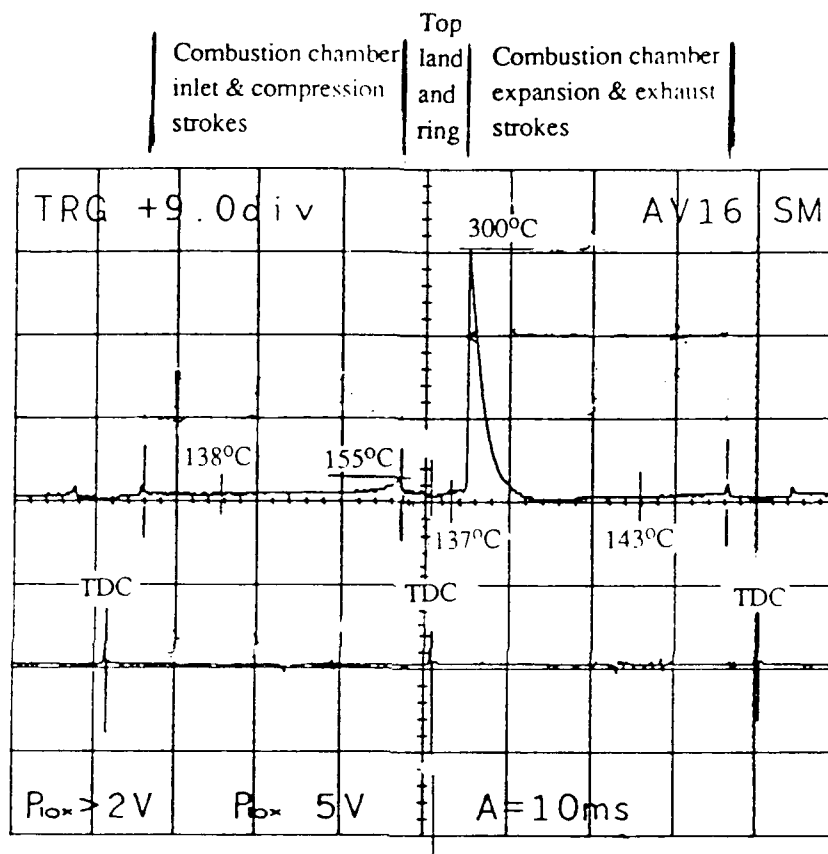
Figure 5. Trace from Flush Window at TDC. No Load.

Figure 5 shows a whole firing cycle observed through a flush-mounted window at top dead centre with the engine running under zero load. Figure 6 magnifies the region around top dead centre just before and after the engine fires. The lower trace shows a pulse at each TDC position and the centre pulse corresponds to the firing point. On the left in figure 6 the quite cold combustion chamber is observed prior to ignition. The temperature of this chamber can be seen to increase just before the top of the piston moves across the window. This may be due to the gases in the chamber being heated due to compression. From A to B we see the top land followed, from B to C, by the piston ring on its upward journey during the compression stroke. The engine then fires and we see successively the piston ring and the top land (C to D) moving down during the firing stroke. Note that the top land is heating up rapidly. Finally the very hot combustion chamber comes into view. Figures 7 and 8 show similar traces for the engine operating respectively under one third and two thirds of full load.

Temperatures calculated in the above manner have been included on figures 5 to 8.

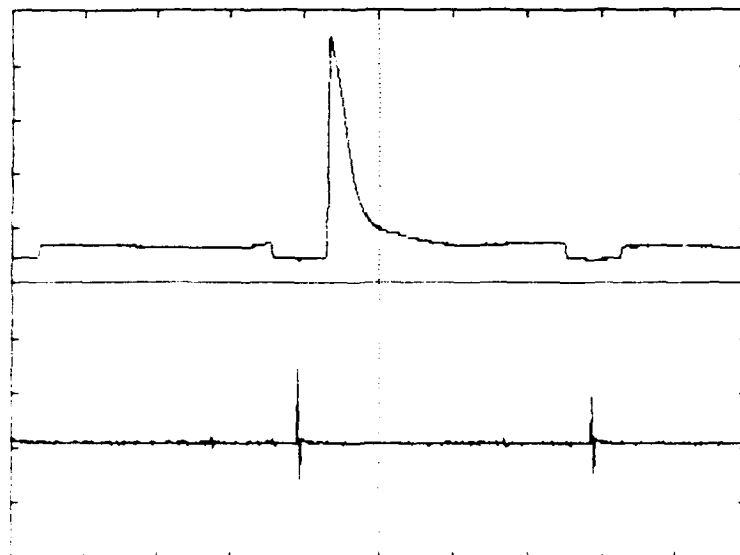
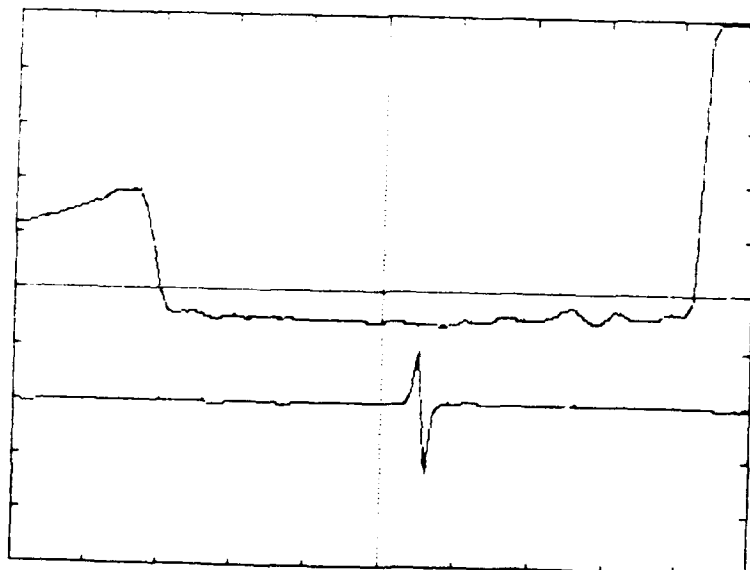
Figure 10. Radiance Trace Under $\frac{1}{3}$ Load

Oscilloscope traces averaged over 80 successive engine cycles are shown in figures 9 to 11. These show less noise than earlier work, indicating the effectiveness of averaging.

From figure 9 to 11 it was possible to estimate the temperature of the

combustion chamber, assuming an emissivity value of unity. At zero engine load this was 250 to 300°C during the firing stroke, rising to 450 to 500°C for full load. Clearly these values are less than the peak temperatures produced during combustion in a diesel engine (approximately 1000 to 2500°C). However it should be noted that the microscope does not see the combustion chamber until approximately 38° of crank angle rotation after TDC, ie after 3.5 ms. Over this time, considerable cooling will have taken place. Very approximate back-extrapolation of the decaying temperature curve observed in figure 11 suggests that the maximum temperature may well have been considerably in excess of 1000°C just after ignition.

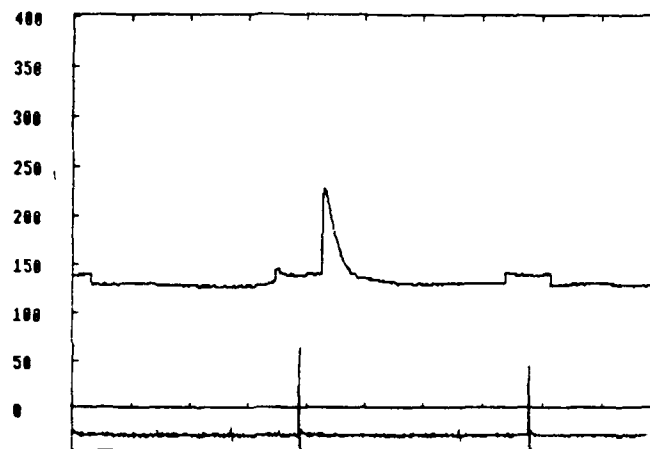
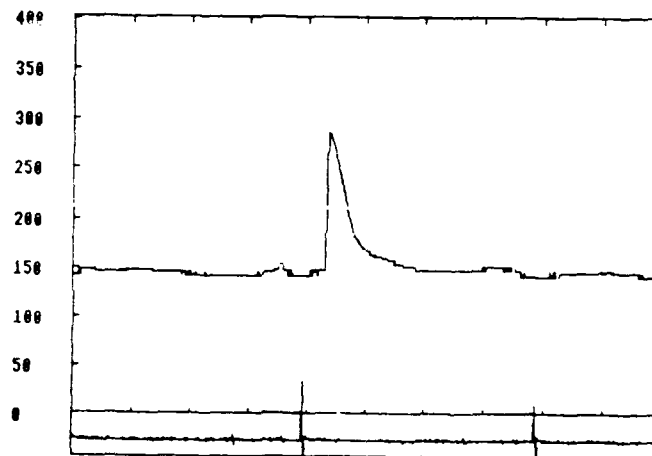
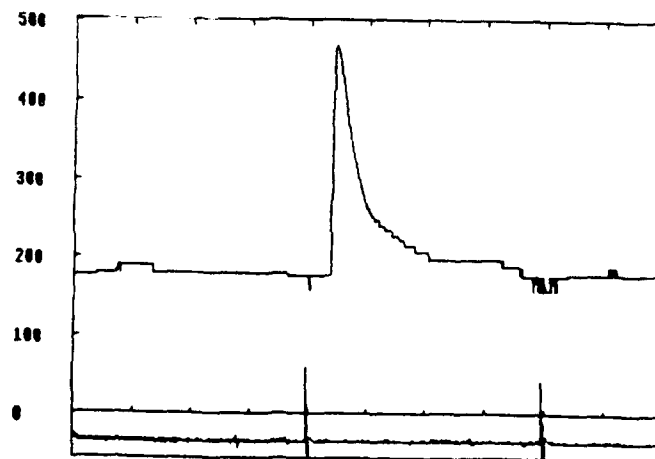
Figure 12. Temperature Curves From Radiance Traces

Figure 12 shows temperature traces calculated from the oscilloscope voltage traces in figures 9a, 10a and 11a. The program to calculate these allowed the user to input emissivities for each part of the trace and in figure 12 an emissivity of 1 was used for those parts of the trace where the combustion chamber was in view and the measured value of 0.7 was employed for the piston ring and land regions.

The resolution of the digital storage oscilloscope was only 8 bits or 1 in 256. This meant that the calculated temperature traces in figure 12 have very coarse resolution in the lower temperature range. This is only a limitation when a small oscilloscope voltage scale is chosen so as to accommodate the whole IR signal trace, including the very large combustion peak on the screen. Much more accurate temperature profiles can be obtained for small parts of the stroke by using a larger voltage scale, as shown in figure 13.

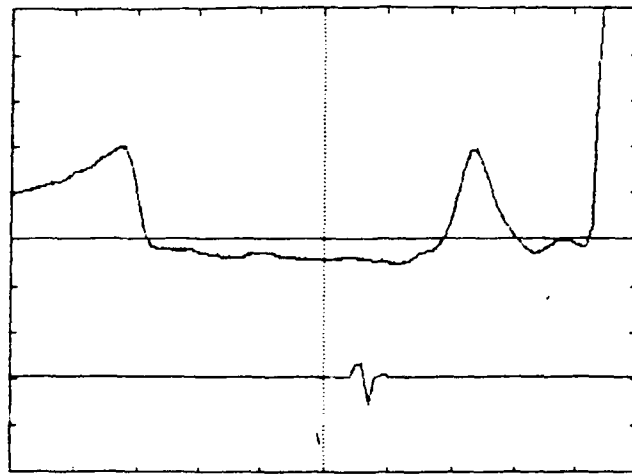
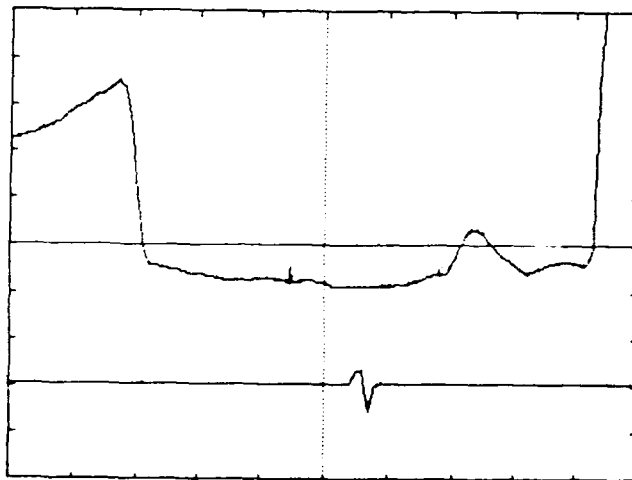
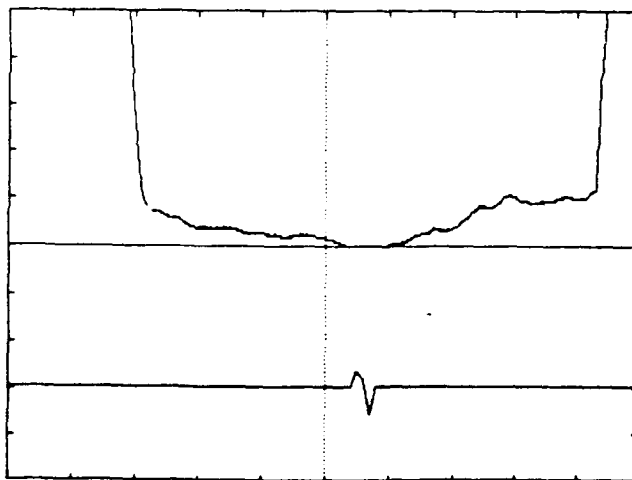
Figure 14. Details of Radiance Traces Around Ignition

Apart from the overall temperature levels reached by the chamber and piston surfaces, the work carried out so far also shows that it is possible to follow the fine details of rapid changes of temperature during a stroke. Figure 14 shows details of the top ring and land area just after firing in one set of tests. At zero and 1/3 load a significant pulse of temperature rise is observed just as the top land comes into view as the piston moves down after ignition. This is swamped by the higher overall temperatures with 2/3 load. This effect may be due to the ingress of a wave of hot combustion gases between the liner and land. It cannot be due to the formation of a higher emissivity deposit at the land/ring junction since this would also cause an proportionate rise in radiance under high load conditions. Some of the results, particularly those at high loads also show a very rapid rise in ring and land surface temperature immediately after firing.

It has been shown that the IR emission method is an effective tool for studying surface temperatures of pistons in an operating engine. The very fast response time ensures that transient effects are observed. Limited results have been obtained so far, with most effort being concentrated upon developing the technique and methodology. However the results show that the temperature of rings, lands and combustion space can be measured with some accuracy and that these, as expected, are very sensitive to engine load. Short duration temperature rises, occurring over less than a millisecond, have also been observed on the piston land just after firing.
